378' WHEC EXPANSION JOINT INSTALLATION
AND PERFORMANCE EVALUATION

Luis M. Baez, et al

Coast Guard Research and Development Center

July 1974

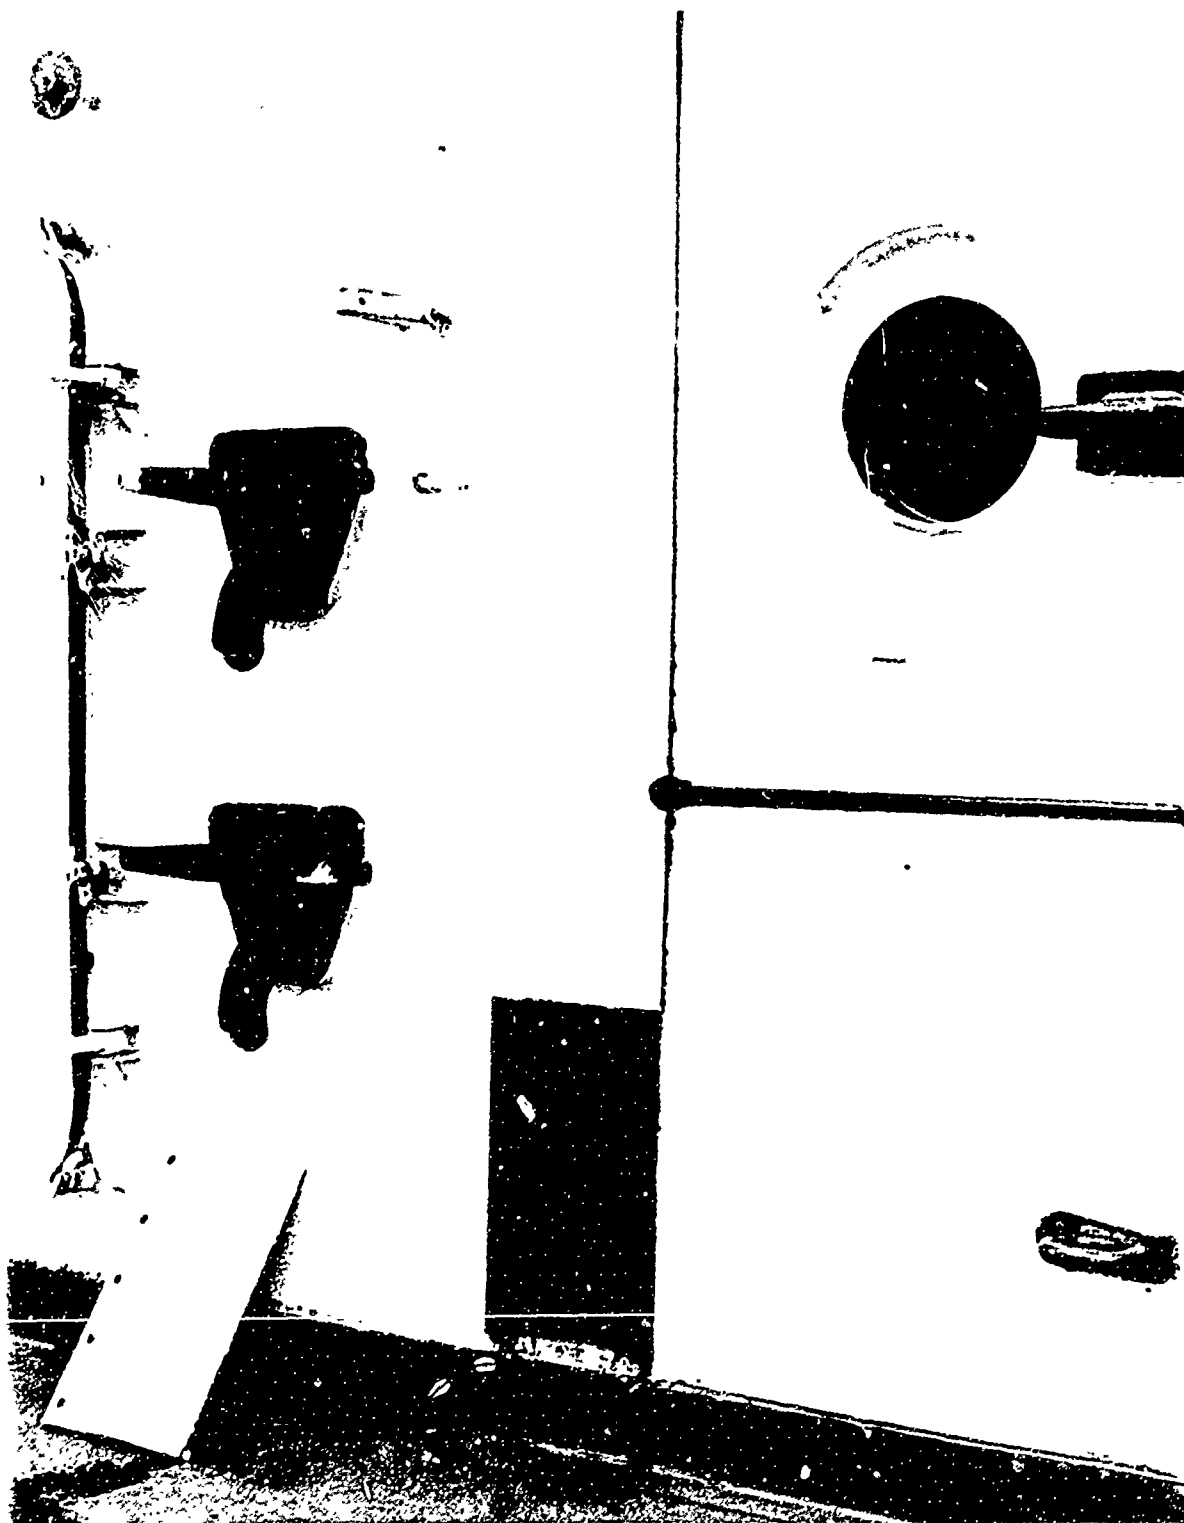
A conventional expansion joint failure (WHEC 327' class) is illustrated in Figures 2 and 3. As might be expected, the sharp radius at the base of the expansion joint concentrated the longitudinal and shear strains in the deckhouse side resulting in a crack at the "hinge" of the joint.

Figure 2. Main deckhouse side of 327' WHEC vessel showing expansion joint.

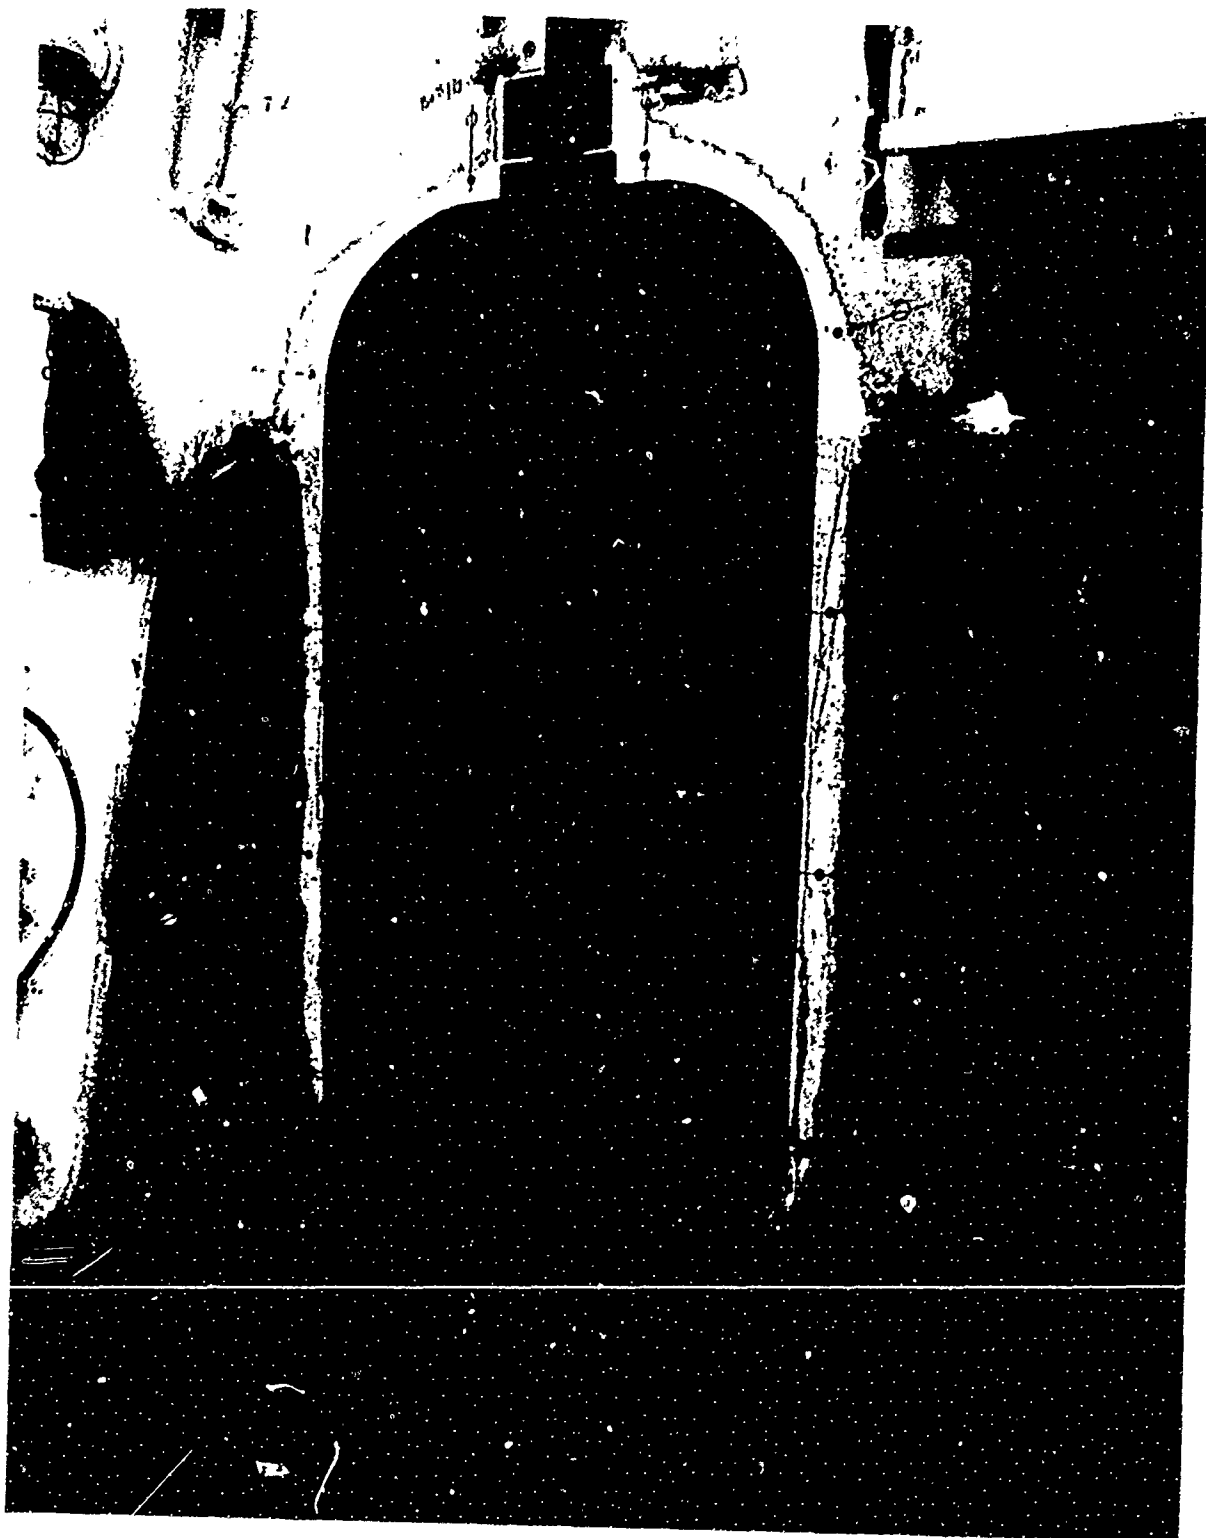
Examination of the data presented in Table 1 reveals that the highest recorded peak-to-peak variation in principal stress at the hinge of the expansion joint is slightly in excess of 12,000 psi. It is important to note here that peak-to-peak readings include tensile stress imposed by hogging plus compressive stress imposed by sagging. Since the calculated hogging stress for this type vessel is approximately .55 of the peak-to-peak stress it follows that the maximum tensile stress experienced during the tests is of the order of 6600 psi. Considering the high yield strength (80,000 psi) and notch toughness of the HY-80 hinge plate, it is apparent that there is ample reserve to account for the higher strains that can be expected at the edge of the cut where the radius becomes finite. Ample safety margin exists even for the mild steel deck in the area.

Figure 5. 378' expansion joint during installation
showing "special radius cut" at hinge of joint.

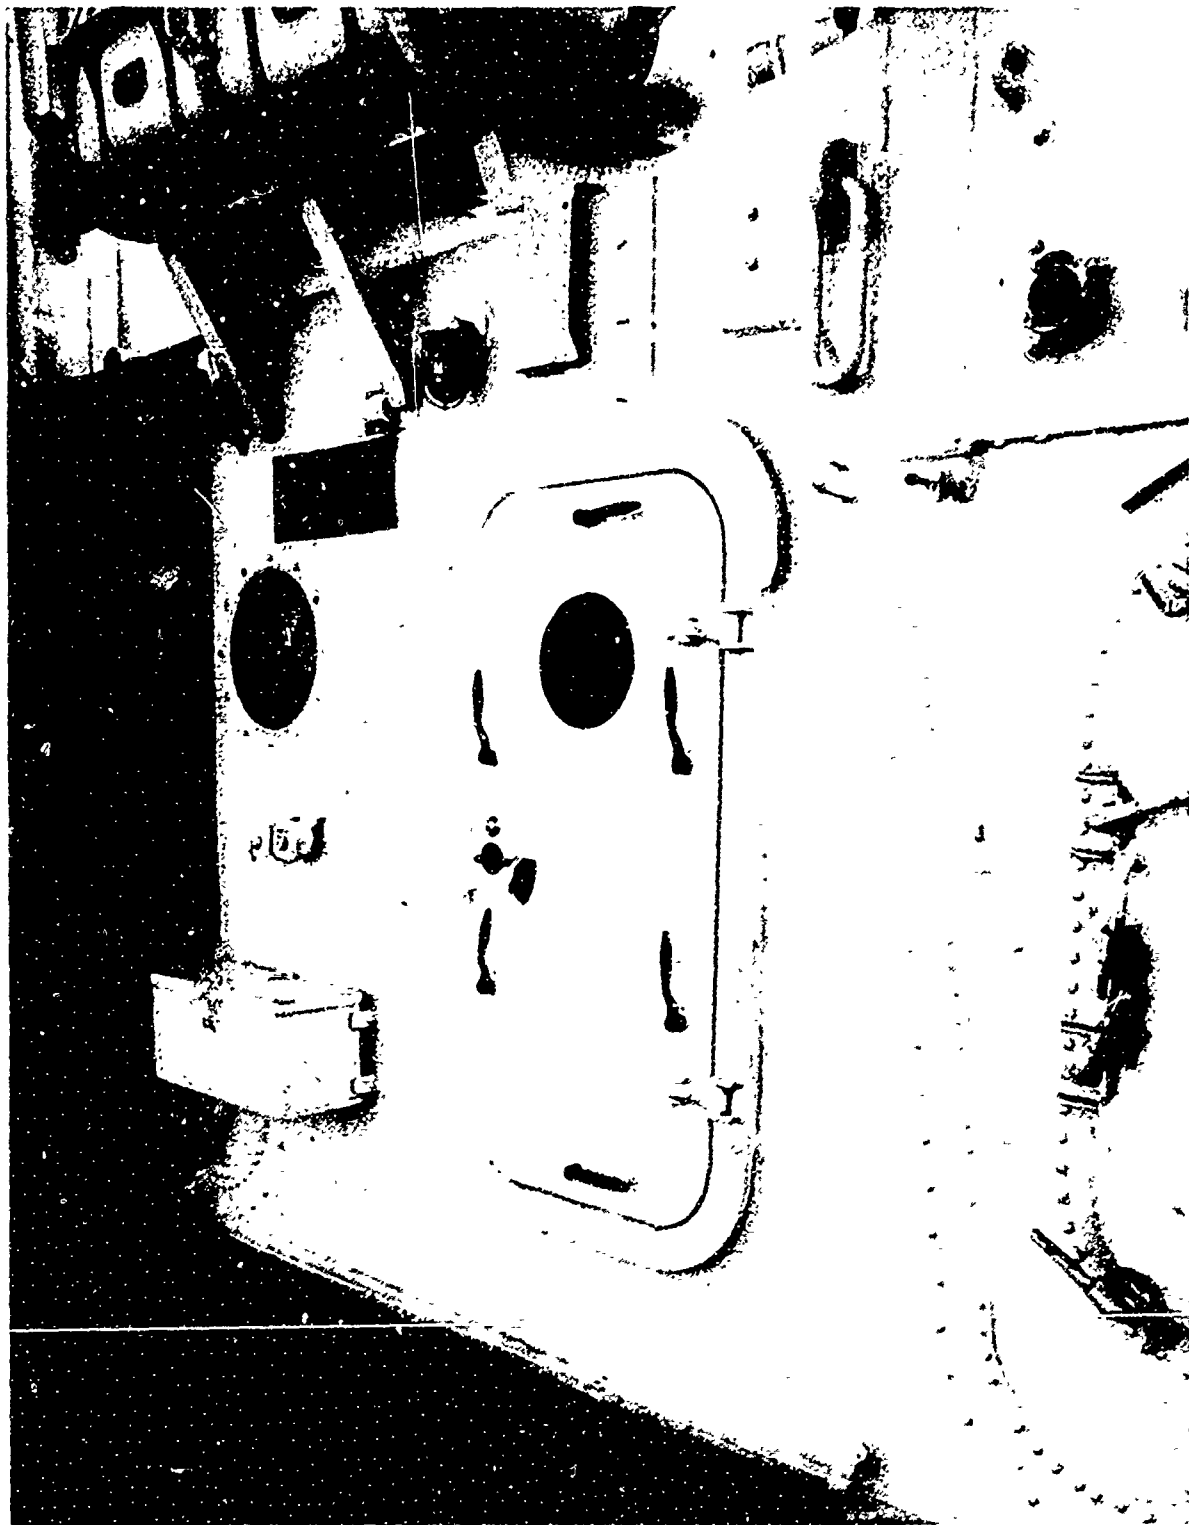
Figure 6. Completed 378' expansion joint
as seen from stbd side of 01 deck.

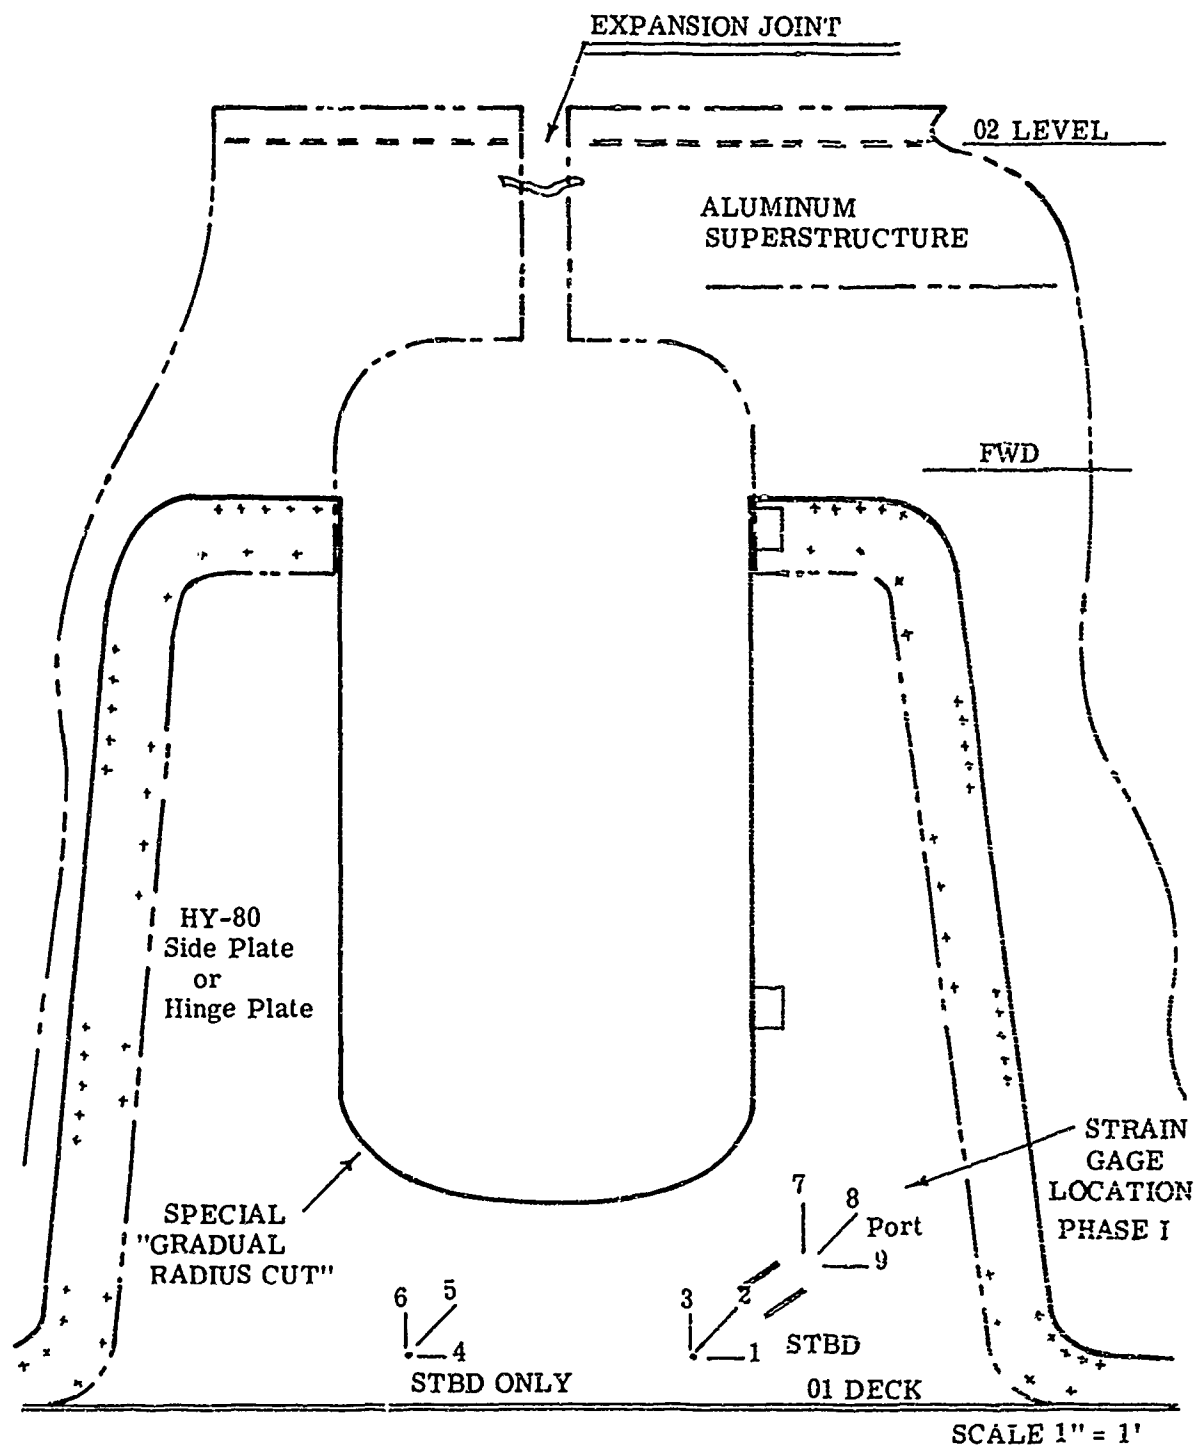
Figure 7. Diagram of hinge plate showing strain gauge locations.

In the initial phase for the stress at the hinge, three rosettes (Figure 8, gauges #1 - #9) were mounted on the HY-80 side on the hinge plate as shown in Figure 7. Two of these rosettes were on the starboard side and one on the port side. For the stress in the shear curtain a single 45° rosette was installed at Frame 288 (Figure 8, gauges #19 - #21). A single strain gauge (Figure 8, gauge #10) was mounted on the transverse beam directly below the expansion joint to ascertain the magnitude of vertical reactions generated by the expansion joint. The remainder of the gauges in Figure 8 were to provide sufficient information to reaffirm the effectiveness of the O1 deck as previously ascertained by NSRDC (reference (1)) on the same class of vessel without the expansion joint. Due to the failure of weather deck gauges #13 and #14 this was not possible during Phase I.

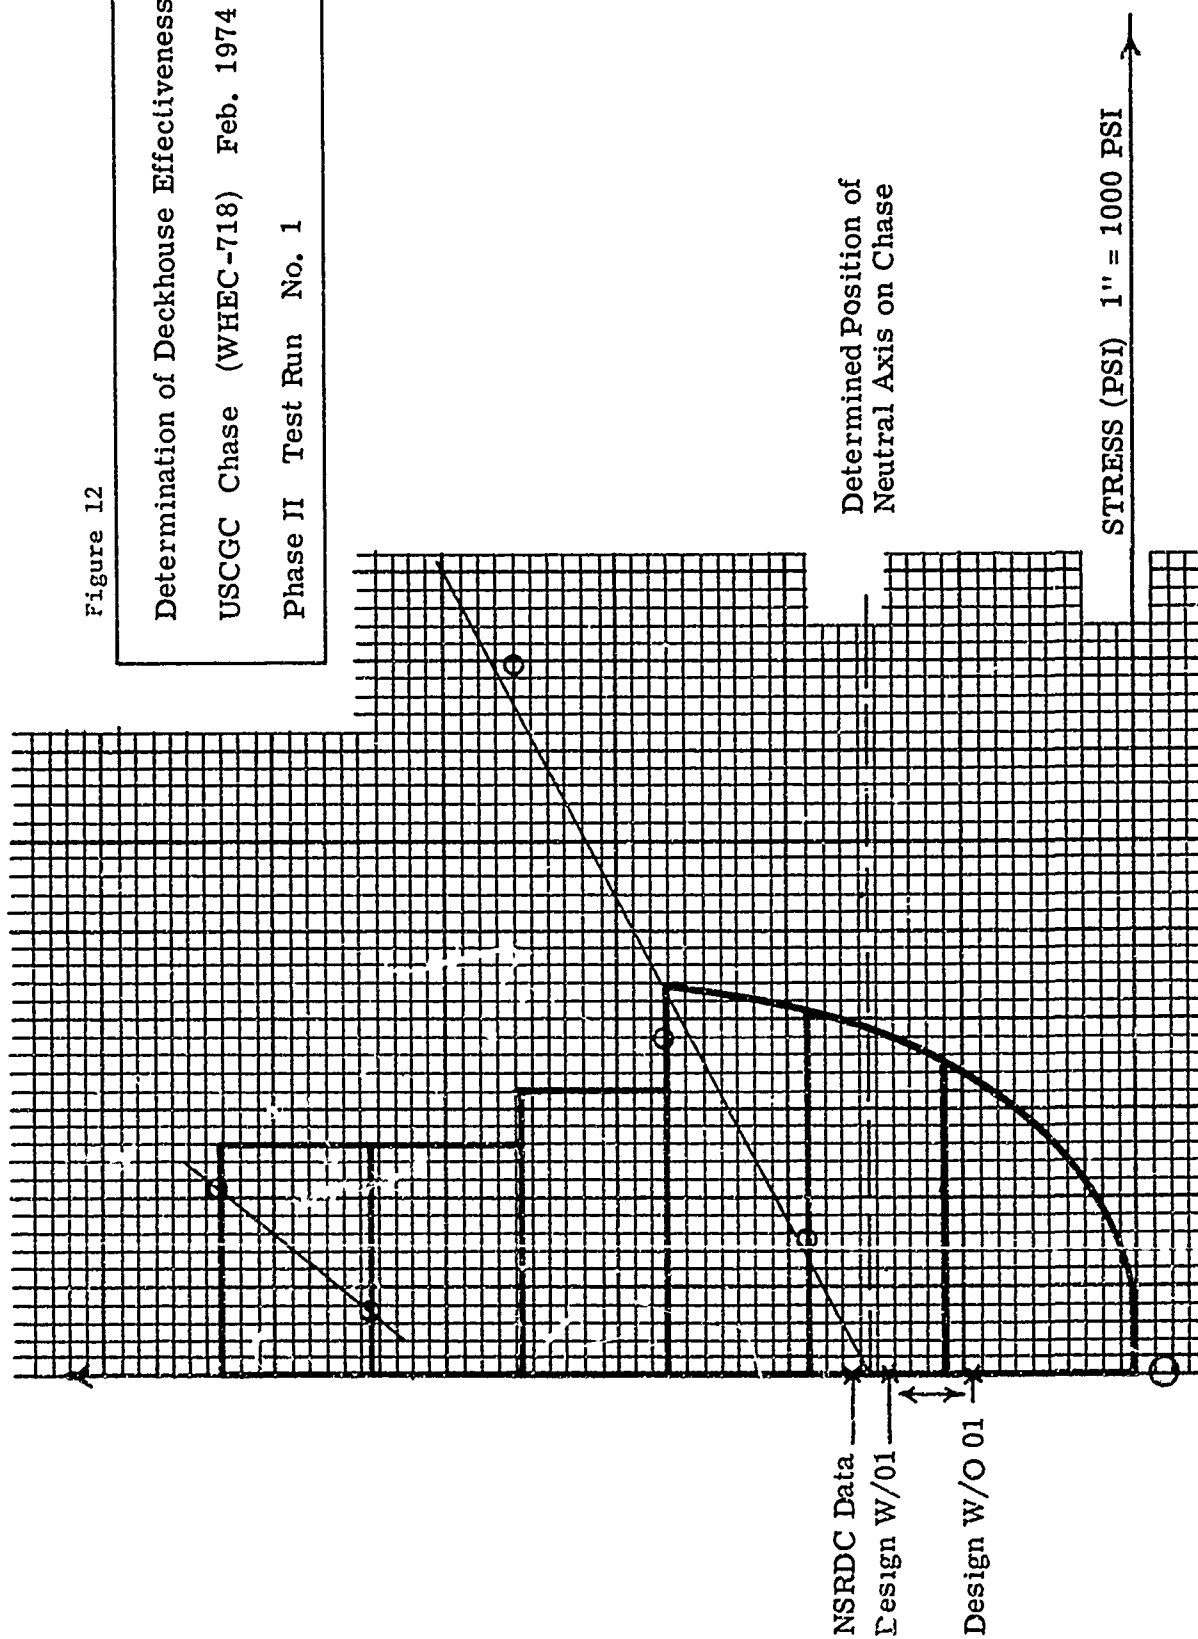
This can be seen in these results in both Figures 12 and 13 where the intersection of the stress distribution line and the ship's centerline is approximately 15 feet from the keel. This result is reasonable in comparison with the original design calculated position of the neutral axis (reference (2)). As can be seen in either Figure 12 or 13, the design position of the neutral axis considering the 01 deck as part of the hull girder is 14.2 feet from the keel and the position of the neutral axis disregarding the 01 deck is a mere 9.3 feet. Since the forward portion of the 02 deck is influencing the hull girder, it can be expected that any measured neutral axis position would be higher than a design calculation disregarding the 02 deck.

Determination of Deckhouse Effectiveness
USCGC Chase (WHEC-718) Feb. 1974
Phase II Test Run No. 1

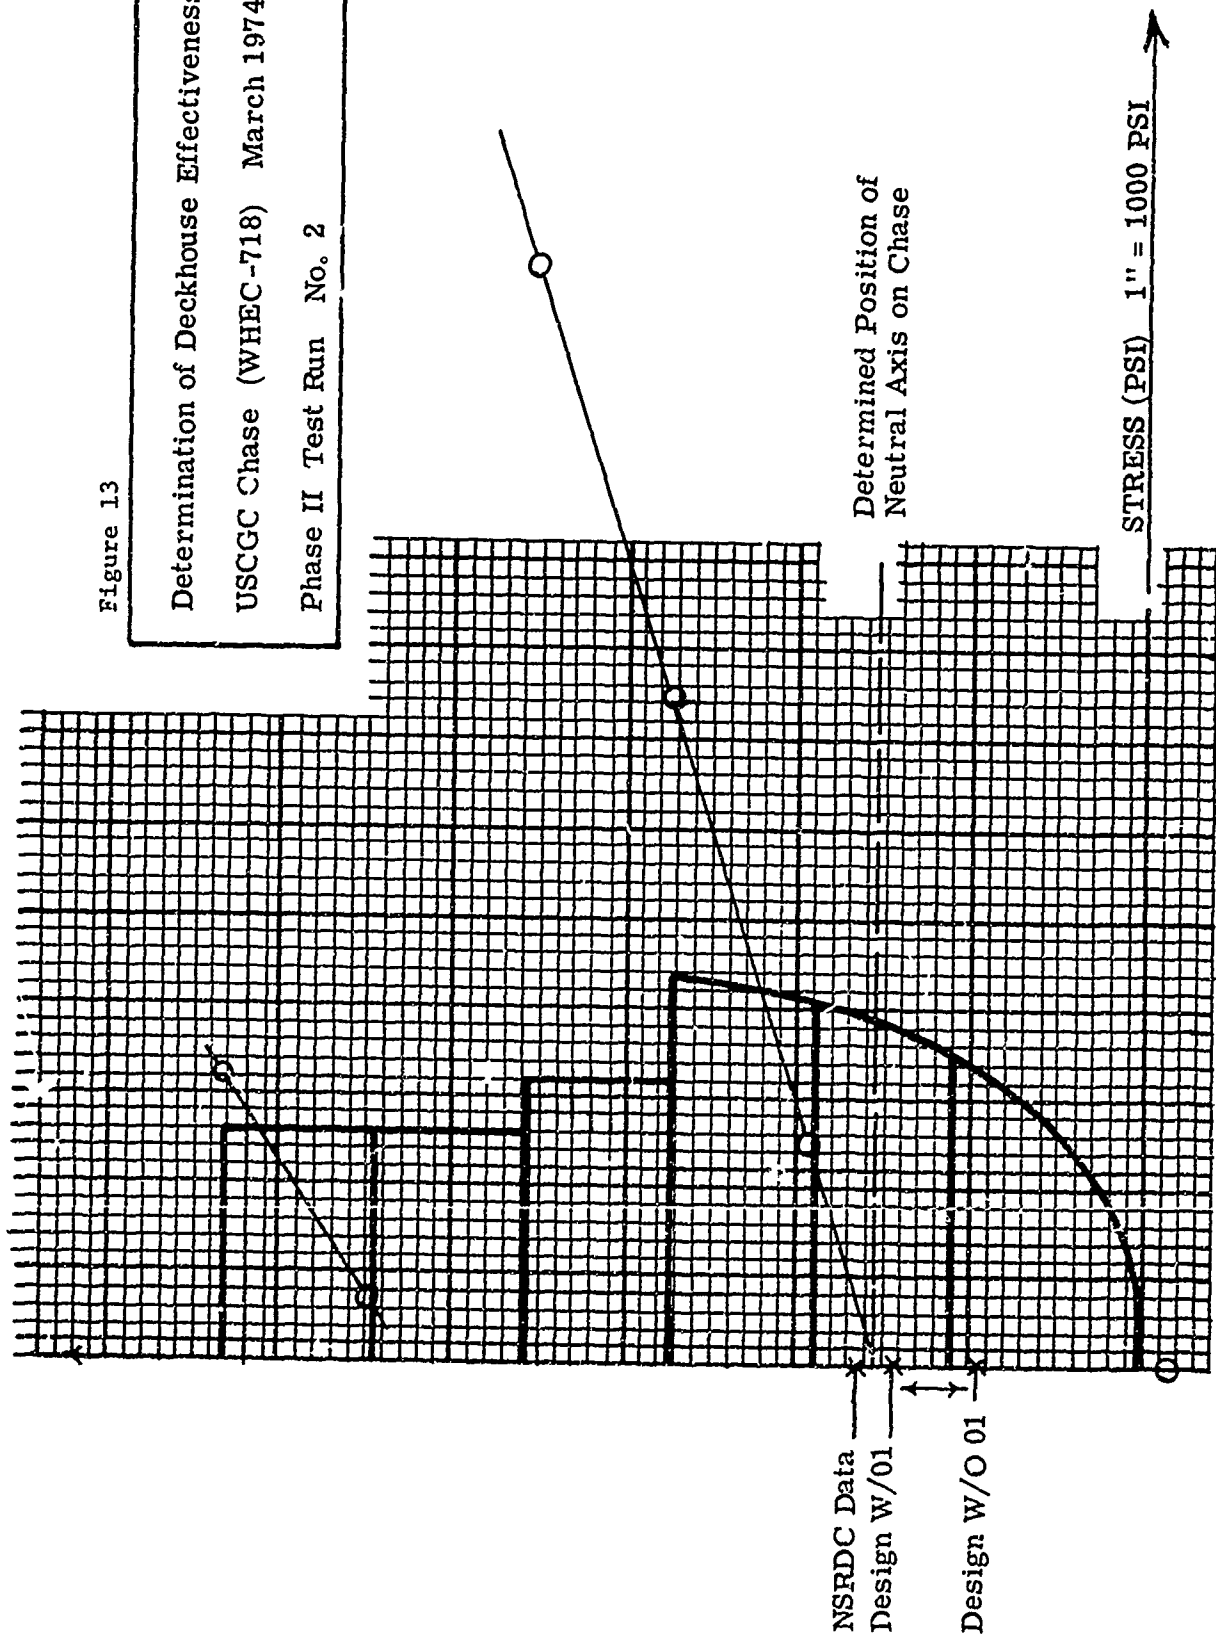
Figure 13

Determination of Deckhouse Effectiveness
USCGC Chase (WHEC-718) March 1974
Phase II Test Run No. 2
